TRI-SERVICE CONFERENCE ON CORROSION

Evaluation of Environmentally Acceptable Protection Schemes for High Strength Steel Fasteners

B. Placzankis, M. Levy, J. Beatty, S. Isserow, M. Kane
US Army Research Laboratory
Materials Directorate
Metals Research Branch
Corrosion Science Team
Watertown, MA 02172-0001

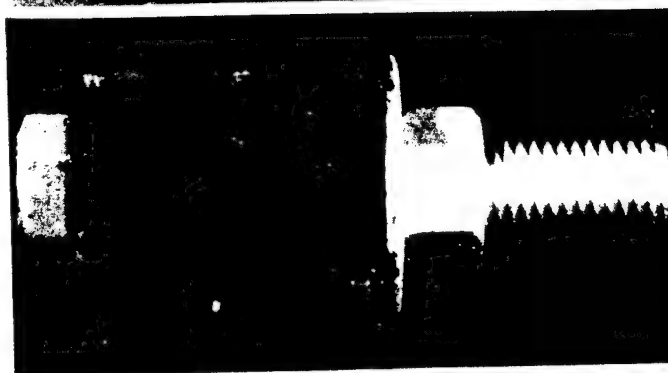
Figure V - Chromated
IVD Aluminum Joint A
Assembly

The Joint A assembly has been described in Figure 2. Note that both blocks of the assembly were fabricated of 4130 steel. For each assembly the bolt, washer and nut were coated with the same material. Table 2 summarizes observations made as a function of time exposure for a total of 312 hours. Figures IV-VI, Appendix A, contain supporting photographic evidence. Cadmium plate and IVD Al (chromated) again were the best performers (no corrosion products 312 hours) followed by Zn-Ni. The Zn-Ni plate (shown at 312 hours) showed no evidence of white corrosion products for 120 hours of exposure.

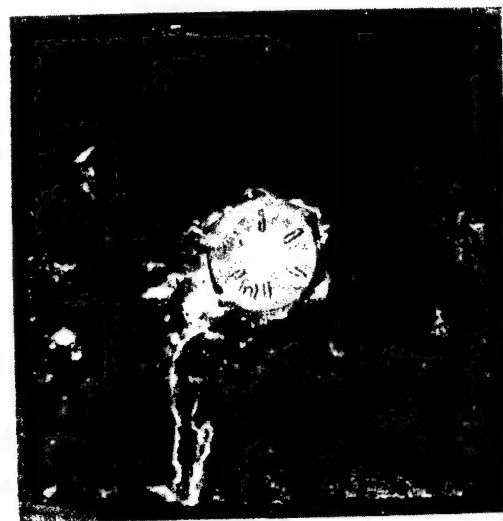
Figure XII - Zn-Ni Plated Joint
C Assembly

This Joint C assembly has been described in Figure 4. Note the different compositions of the two blocks in the assembly; Armor steel and Al 5083. For each assembly tested, the bolt, nut and washer were coated with the same material. Table 4 summarizes observations made for each coating as a function of exposure time. Figures XI-XIII, Appendix A, (312 hours) contain corresponding photographs. There was no evidence of white

corrosion products or rust for either the Cd or IVD Al (chromated) coated assemblies throughout the 312 hours. Zinc-Nickel coatings were free of white corrosion products for 96 hours. White corrosion products appeared thereafter increasing with increasing time of exposure. These coatings may be ranked in the following order of decreasing merit, based on a total exposure time of 312 hours: Cd, tied with IVD Al (chromated), followed by Zn-Ni.

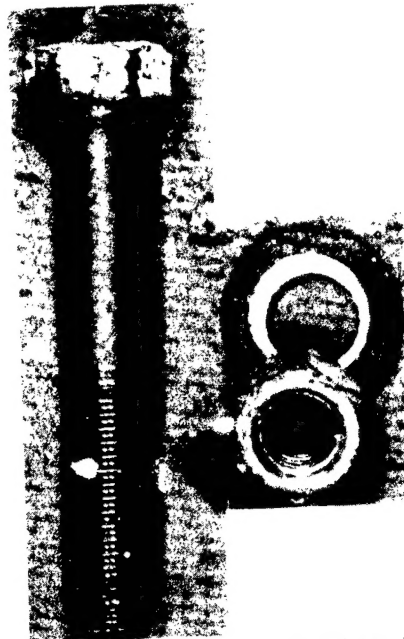
Figure XXIII - Zn-Ni Plated
Joint A Assembly. Mixed with
Cd. Disassembled to Show
Amounts of Corrosion

Complementary photographs at 312 hours of immersion are shown in Figures XX-XXV: Appendix B. The potential of the Cadmium coated assembly remained relatively stable throughout the entire test, indicative of its excellent corrosion resistance. The Zn-Ni plated bolt with Cd washer and nut exhibited very little rust on the bolt and washer after 12 days of immersion. This coincided with the potential stabilizing to that of Cadmium after an initial rapid increase over the first two days to the Cadmium potential. A gradual rise in potential beginning between 9 and 10 days culminating with the appearance of rust indicated that the Cd coating on the nut and washer had broken down. The IVD Al specimens again displayed performance that was dependent upon coating thickness. In the case of the thick chromated IVD Al, E-corr measurements, while somewhat less stable, slowly increased from (-0.775) to (-0.750) similar to the values recorded for Cd. The two thin IVD coatings began negative with respect to steel at around (-0.75) and

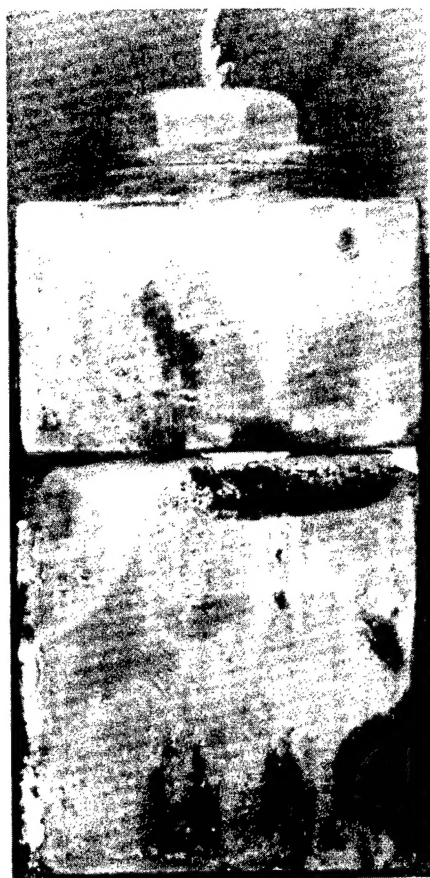
Figure XXVI - Cd Plated
Joint B Assembly

For these joint assemblies, potential-time curves are plotted in Figure 9, and corresponding photographs are contained in Figures XXVI-XXX.

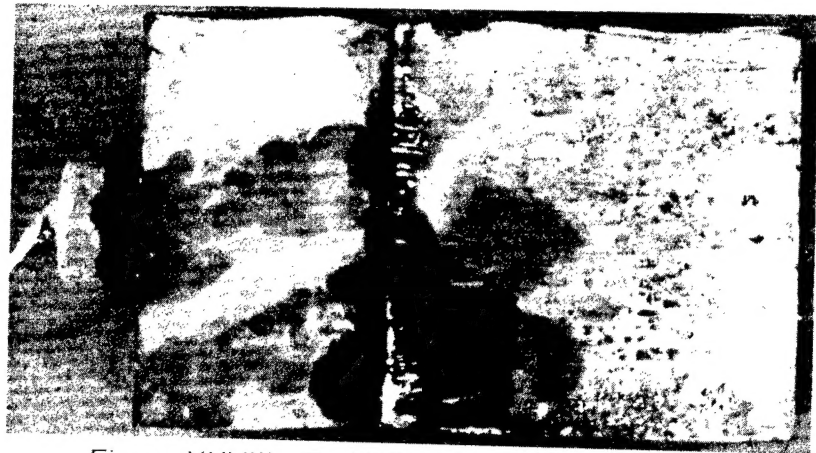
Figure XXVIII - Zn-Ni Plated Joint B Assembly
